DATA REPORT FOR SONAR/CCTV PIPELINE INSPECTION

Interceptor Inspection

Data Report: **Interceptor Inspection**

Location: The interceptor inspection took place at University Athletic Field parking lot into the woods.

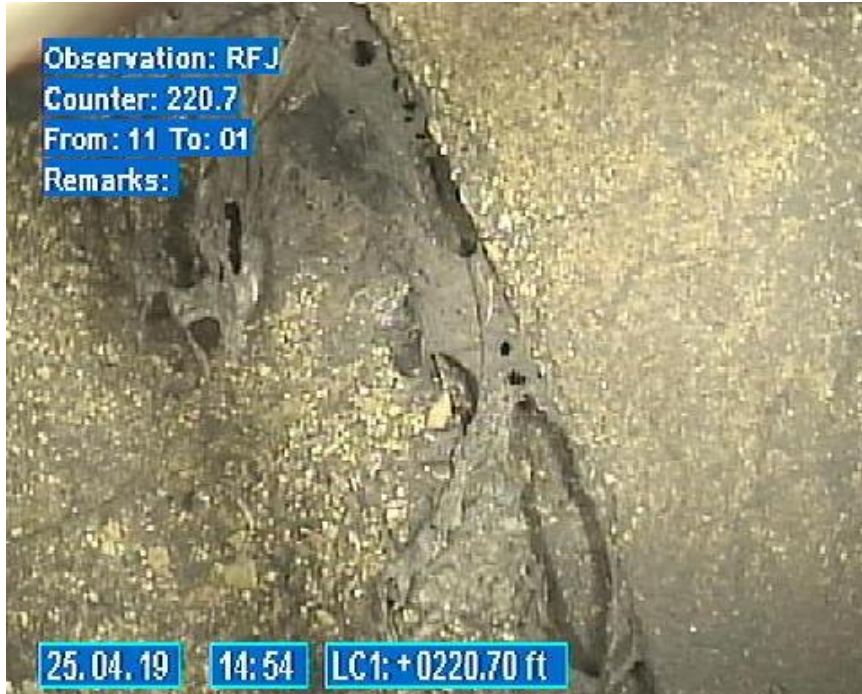
Image at 220.70' shows fine roots.

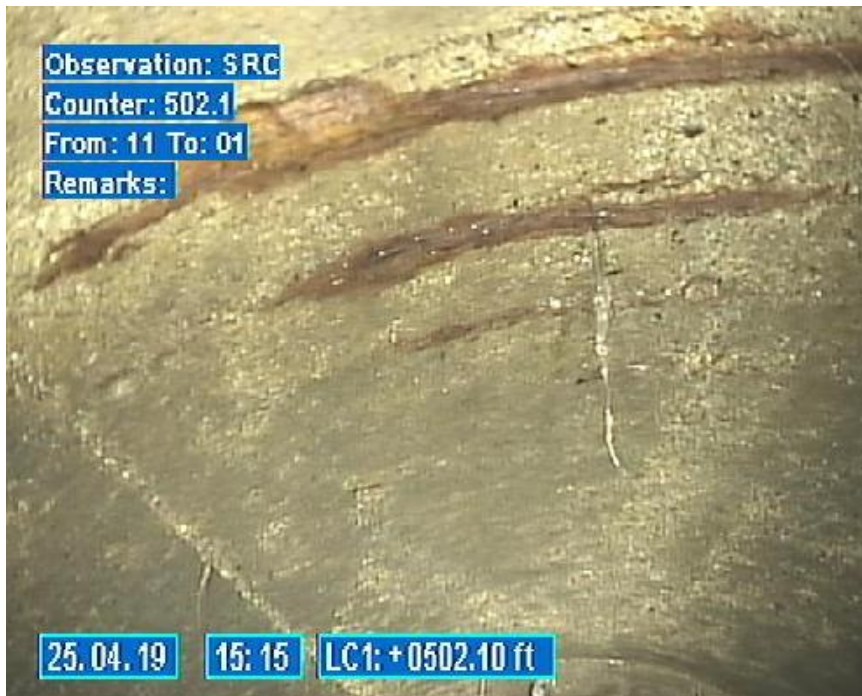
Image at 502.10' shows surface reinforcement.

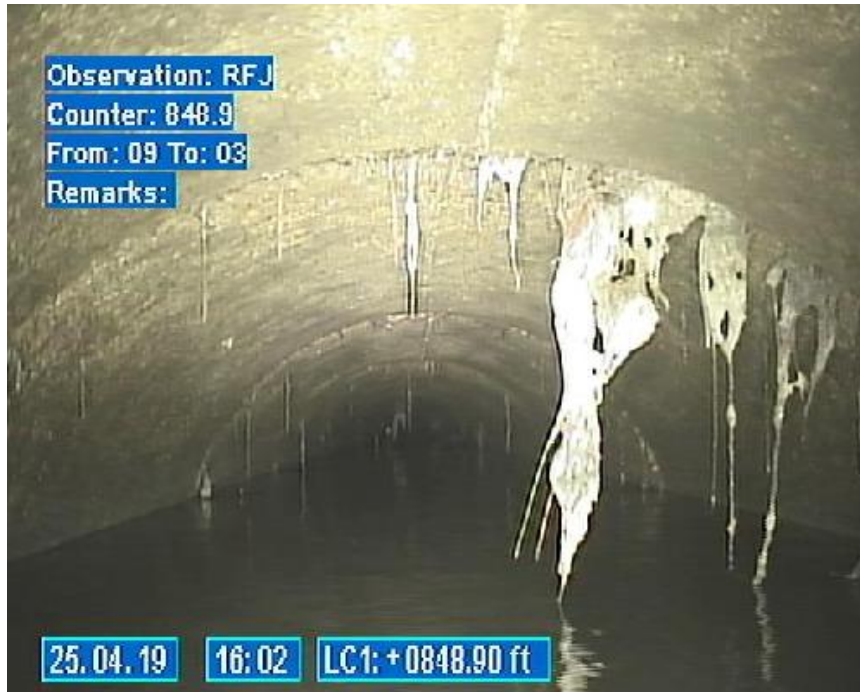
Image at 848.90' shows fine roots.

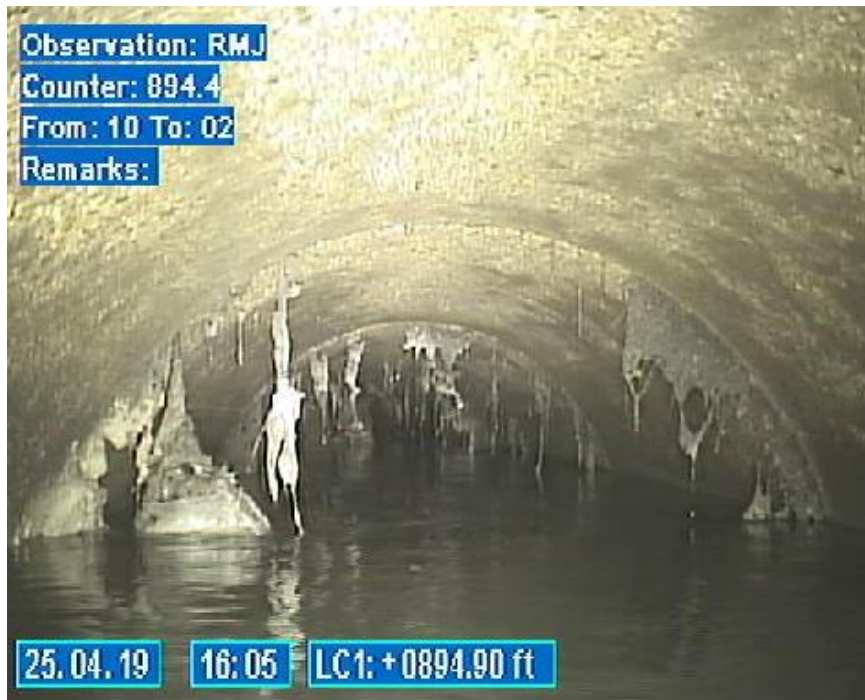
During the inspection of this section of pipe, the field crew was able to get the pipe strung with a rope from manhole to manhole. At around the 800 foot mark they started to notice some roots starting to enter the pipe though the joints. The size of the roots continued to get larger the farther down the pipe that they got. At around 940 feet the roots got be enough that they could not pull the raft down the pipe any longer. The survey had to be abandoned at that point.

Image at 894.90' shows medium roots.

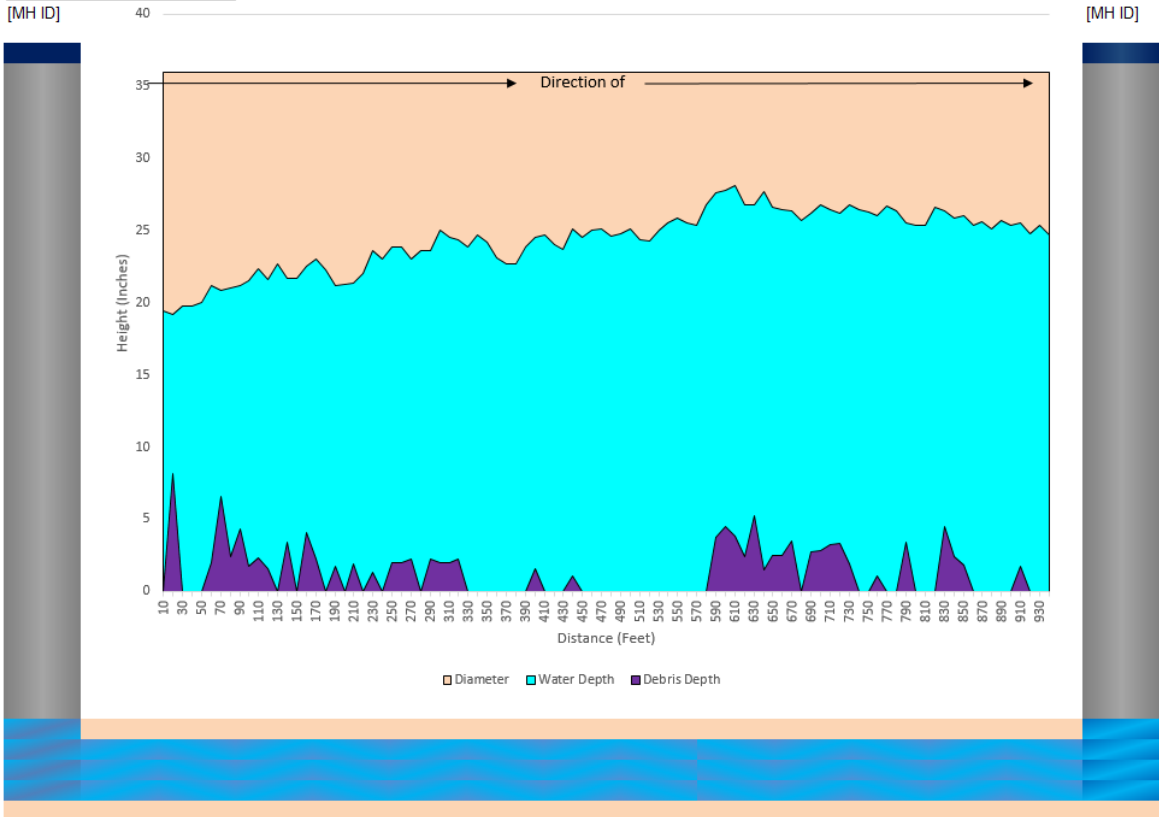
Diameter: 36 Inches
Avg. Debris Depth: 2.16 Inches
Avg. Water Level: 21.22 Inches
Approx. Debris Vol.: 43.20 Cubic Ft.

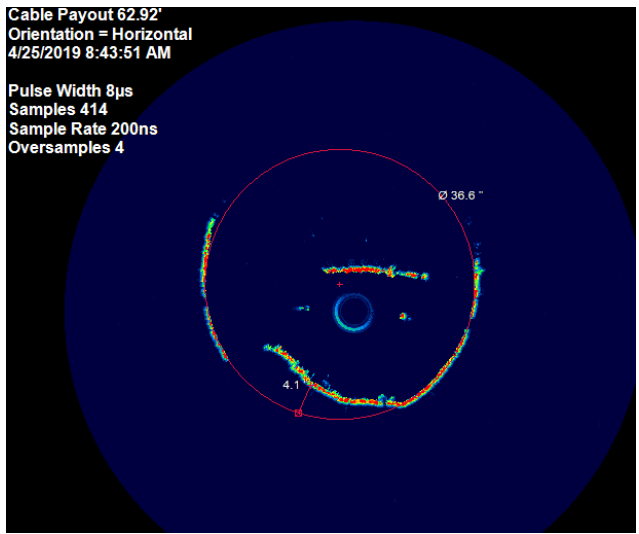
Image at 62.92' shows 4.1" of debris.

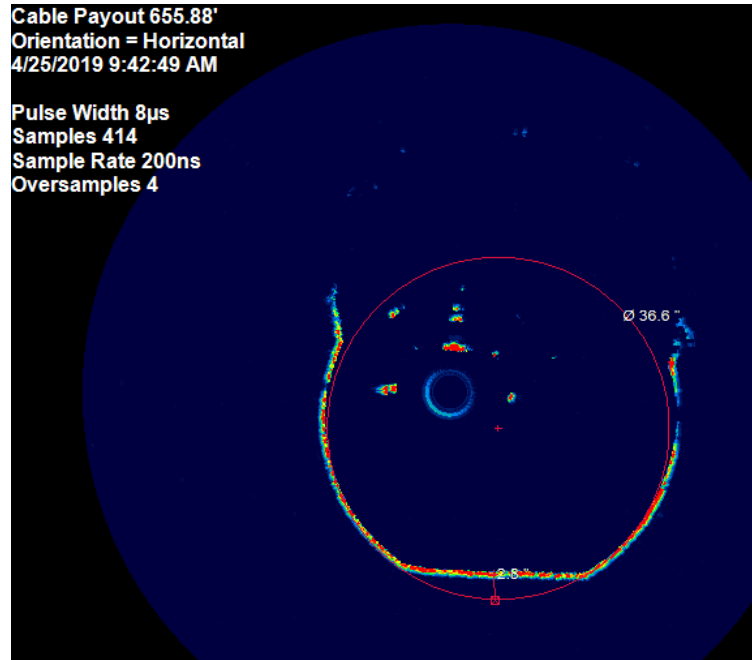
Image at 655.88' shows 2.5" of debris.

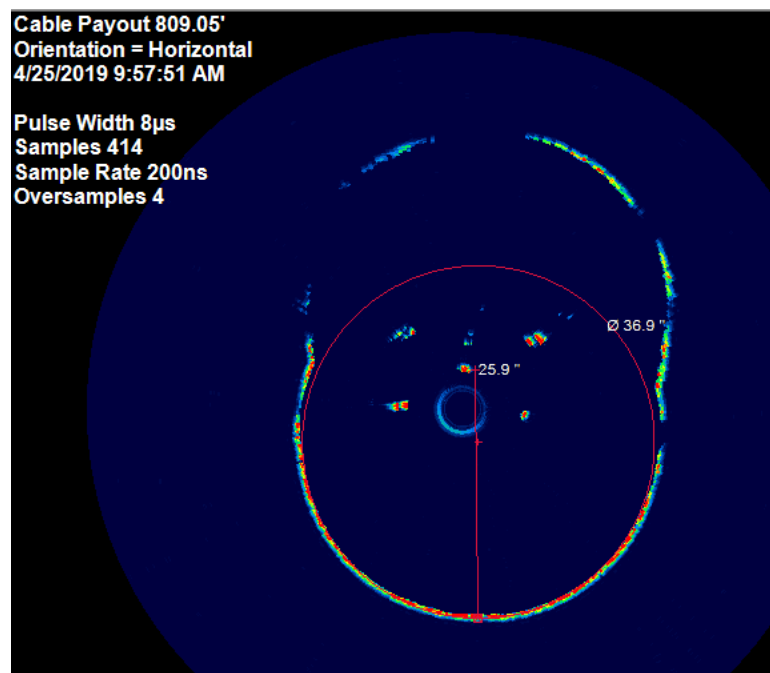
Image at 809.05' shows 25.9" of water.
