DATA REPORT FOR SONAR/CCTV PIPELINE INSPECTION

1 River Rd Inspection

Data Report: 1 River Rd Inspection

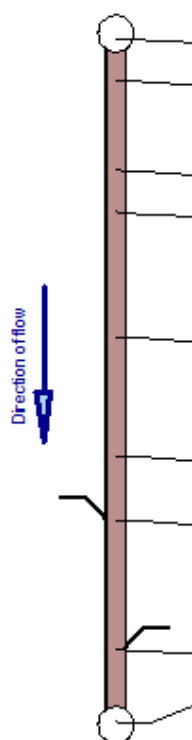
SCMH-5182 to SCMH-6168

21.40	DSZ	001	00:01:00	Start (1): Deposits Settled Other from 5 to 7 o'clock, Loss of cross sectional area = 10 %, Debris.
	67.10	LL	002	00:02:32	Line Left, Deviation = 25 %

88.30	SAV	003	00:03:06	Start (2): Surface Damage Aggregate Visible from 9 to 3 o'clock
	152.80	RFJ	004	00:04:23	Roots Fine Joint from 10 to 2 o'clock, Joint

213.20	RMB	005	00:06:25	Roots Medium Barrel from 11 to 1 o'clock, Loss of cross sectional area = 5 %
	246.20	RML	006	00:07:20	Roots Medium Lateral from 3 to 4 o'clock, Loss of cross sectional area = 10 %
		TB	007	00:07:23	Tap Break-In/Hammer at 2 o'clock, Diameter = 6 in.

311.80	TBI	008	00:09:14	Tap Break-In Intruding at 10 o'clock, Diameter = 4 in., Intrusion = 4 in.
348.50	SAV		00:10:59	End (2): Surface Damage Aggregate Visible from 9 to 3 o'clock	
	DSZ		00:11:02	End (1): Deposits Settled Other from 5 to 7 o'clock, Loss of cross sectional area = 10 %, Debris.	
	AMH	009	00:11:05	Access Point Manhole, SCMH-5182

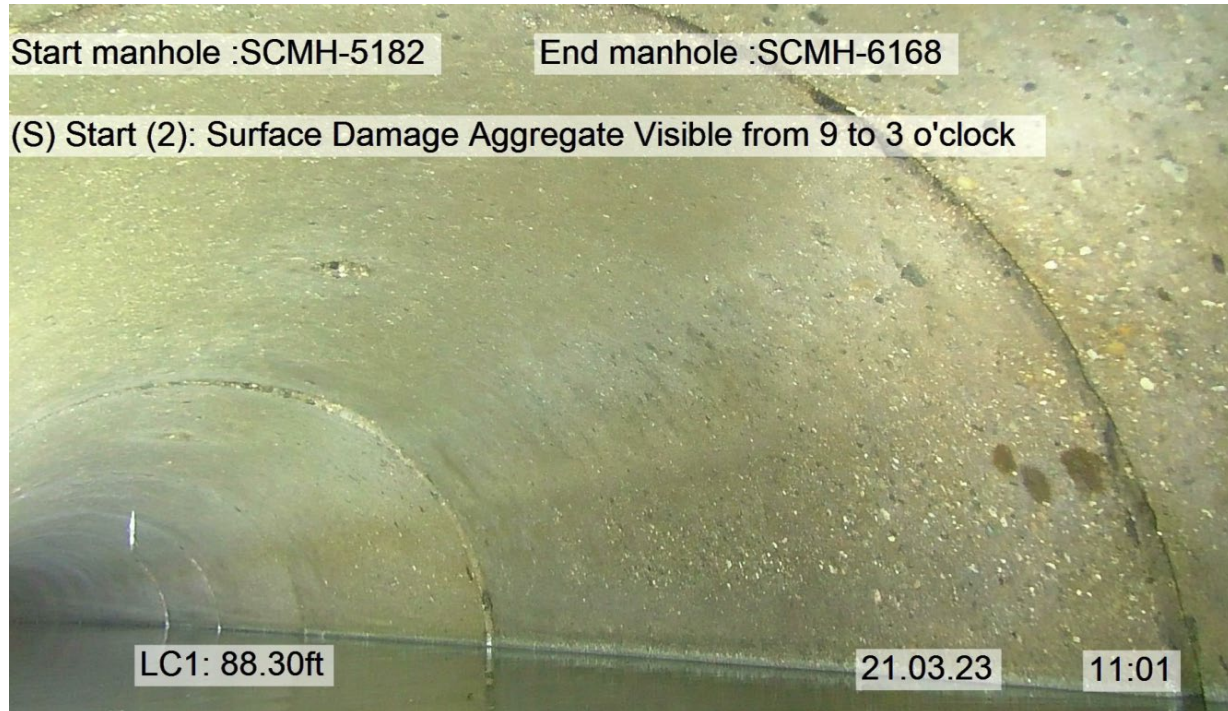
Image at 88.30' shows aggregate visible.

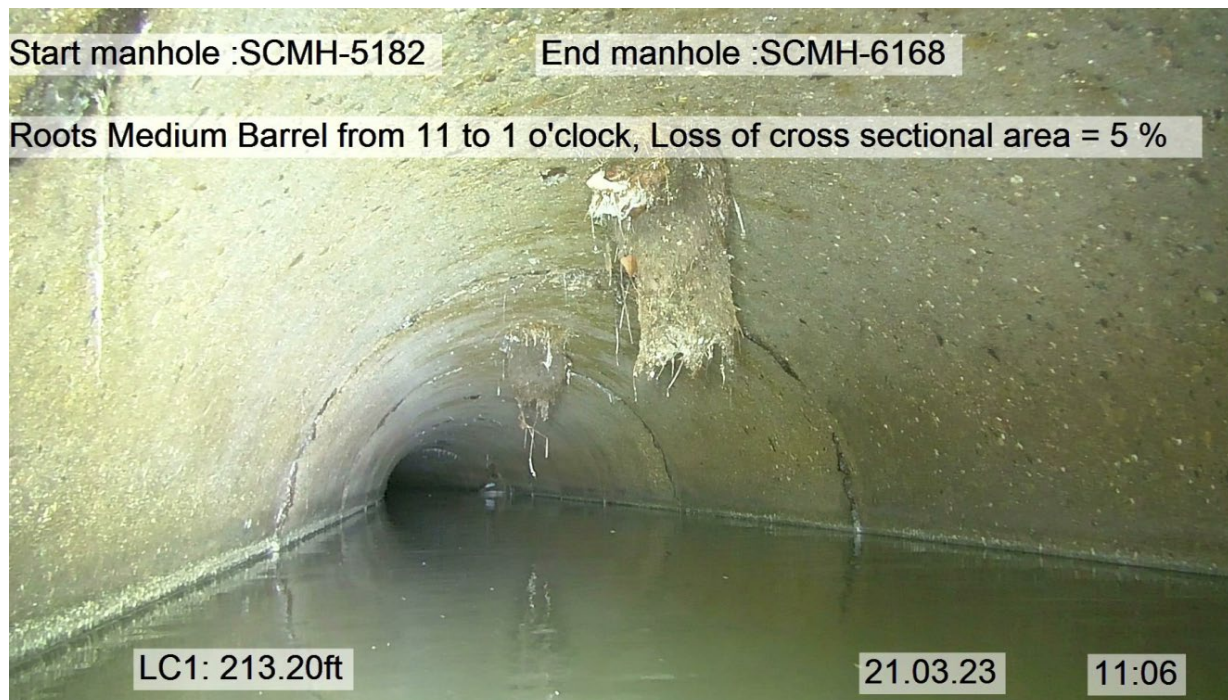
Image at 213.20' shows medium roots.

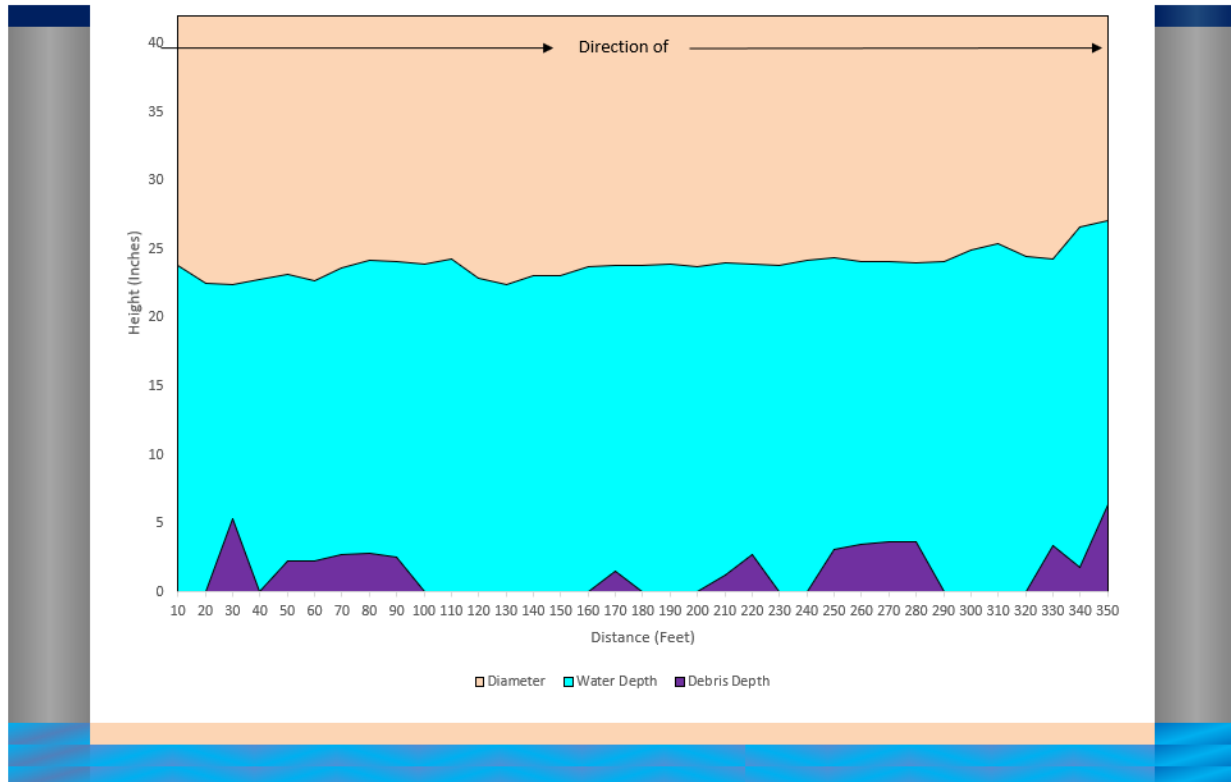
Pipeline Debris Graph

Diameter: 42 Inches
Avg. Debris Depth: 1.40 Inches
Avg. Water Level: 23.92 Inches
Approx. Debris Vol.: 53.06 Cubic Ft.

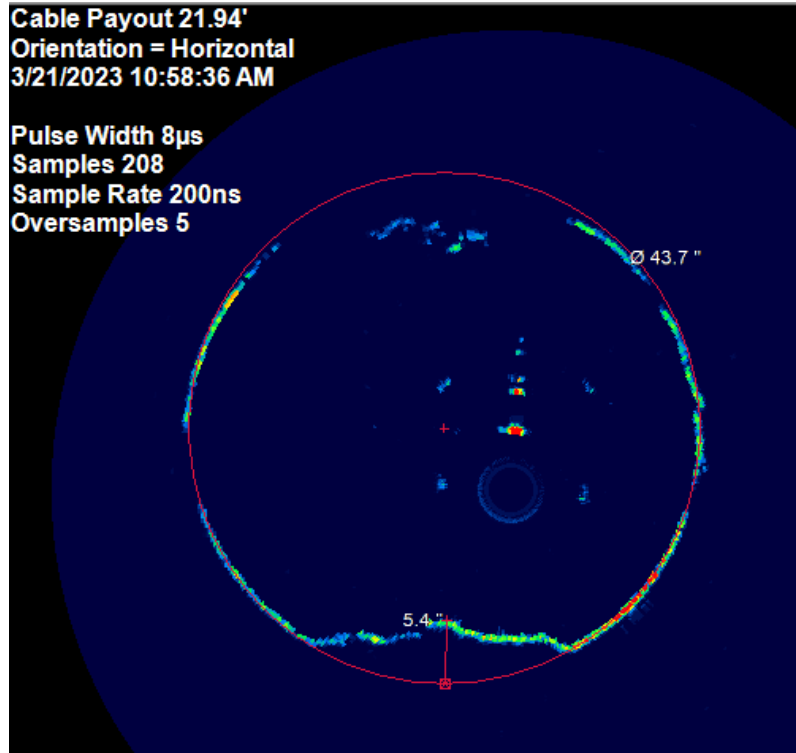
Image at 21.94' shows 5.4" of debris.

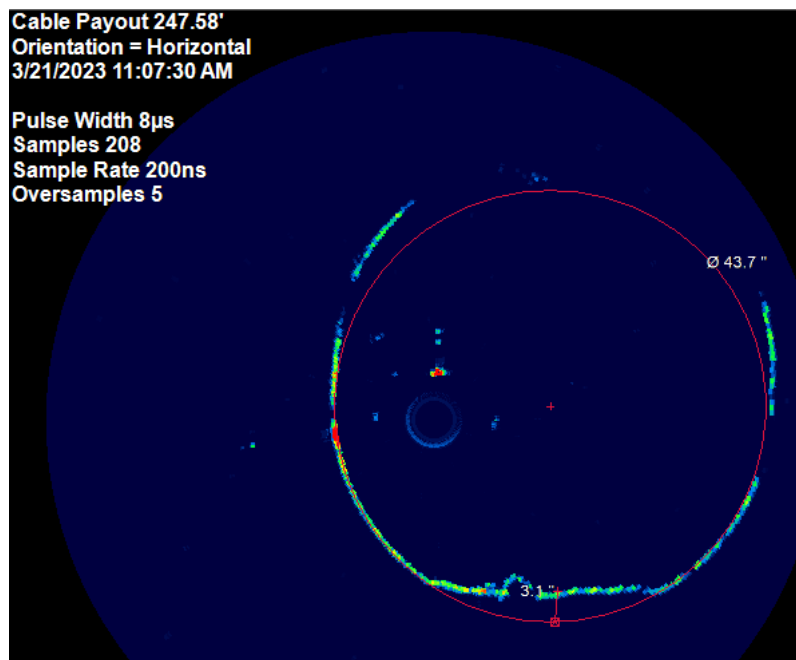
Image at 247.58' shows 3.1" of debris.

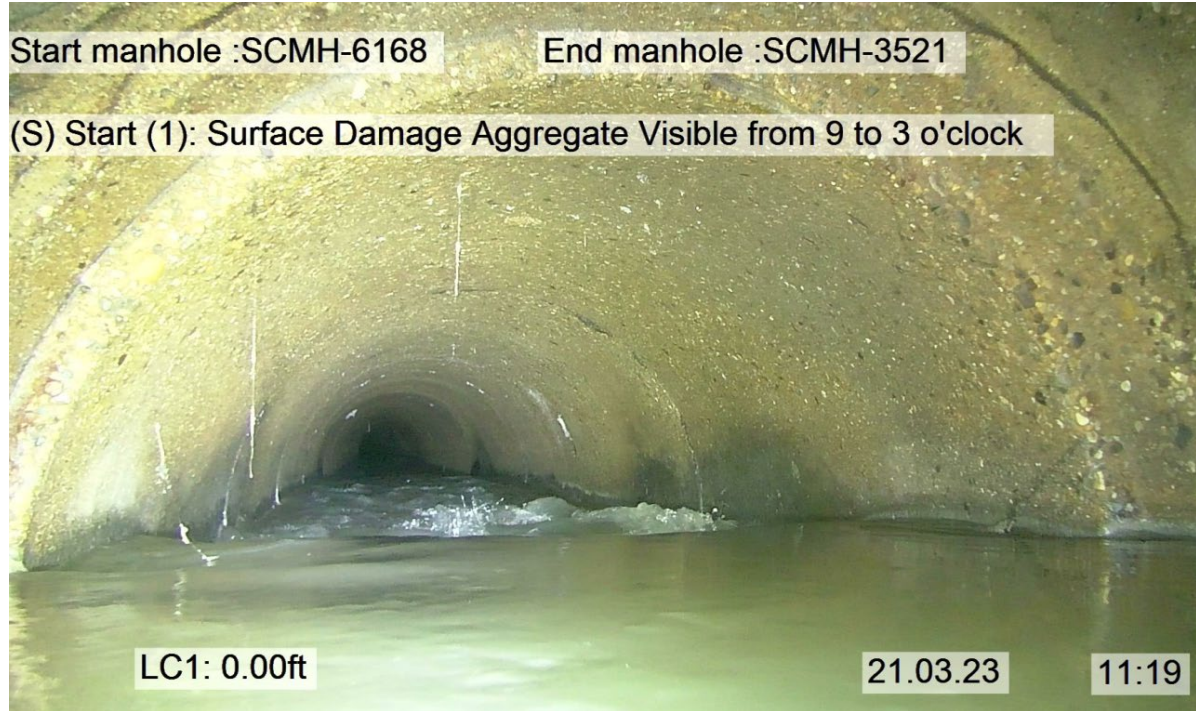
Image at 0.00' shows aggregate visible.

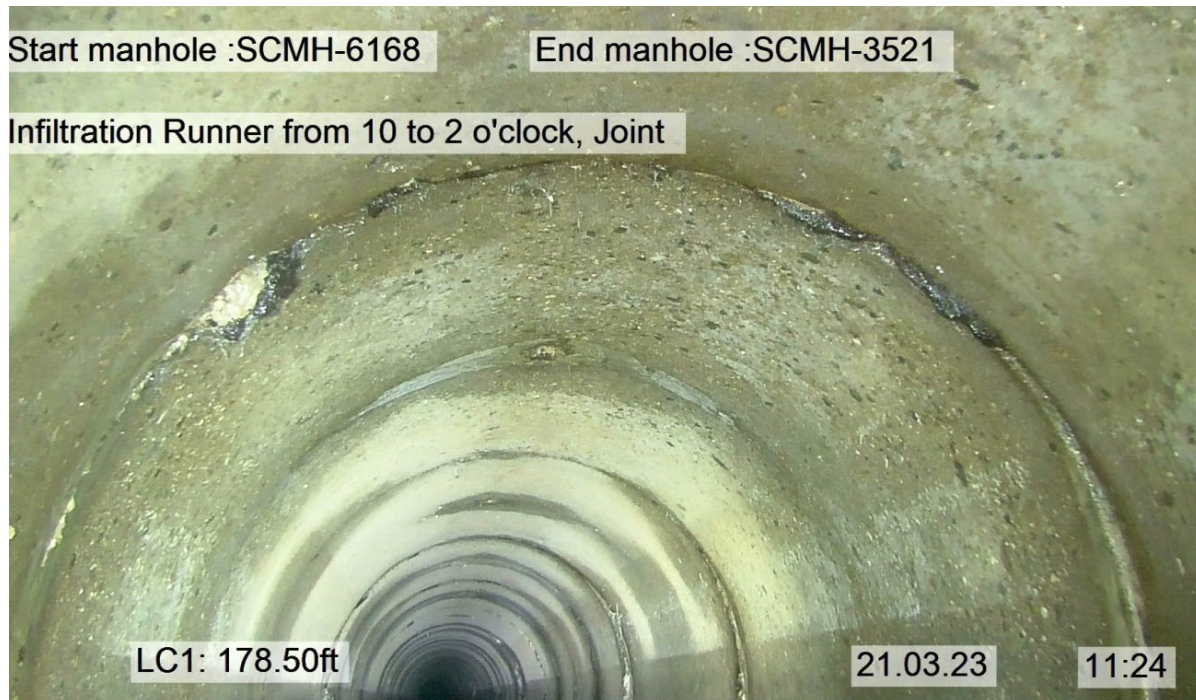
Image at 178.50 shows infiltration.

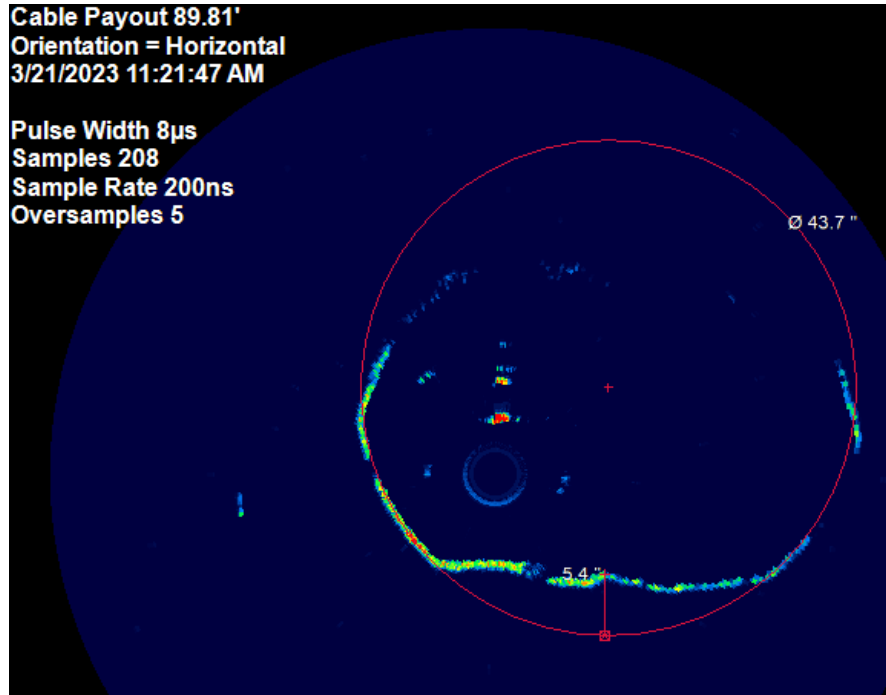
Image at 89.81' shows 5.4" of debris.

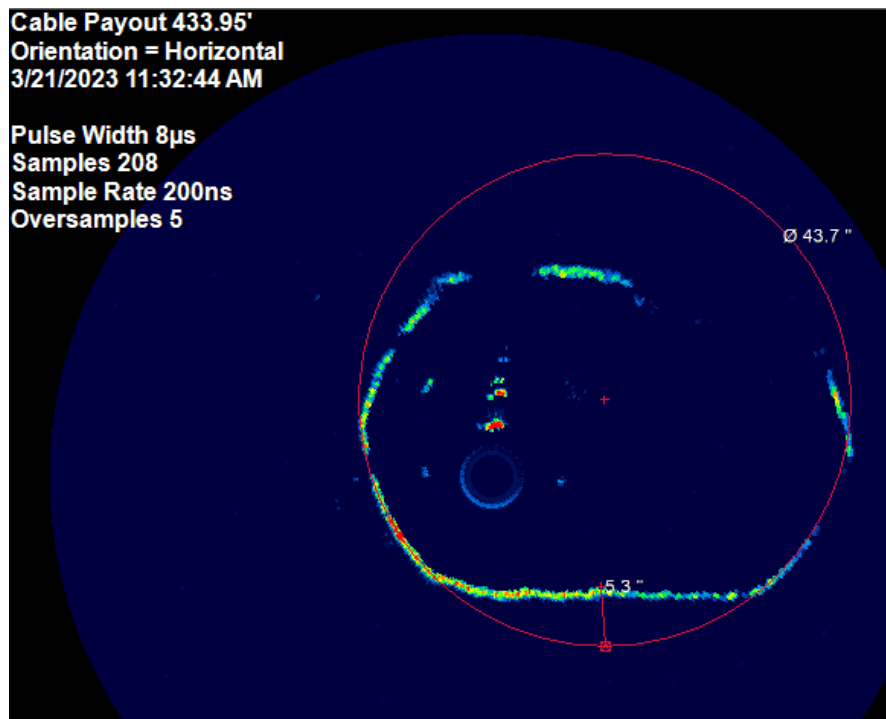
Image at 433.95' shows 5.3" of debris.

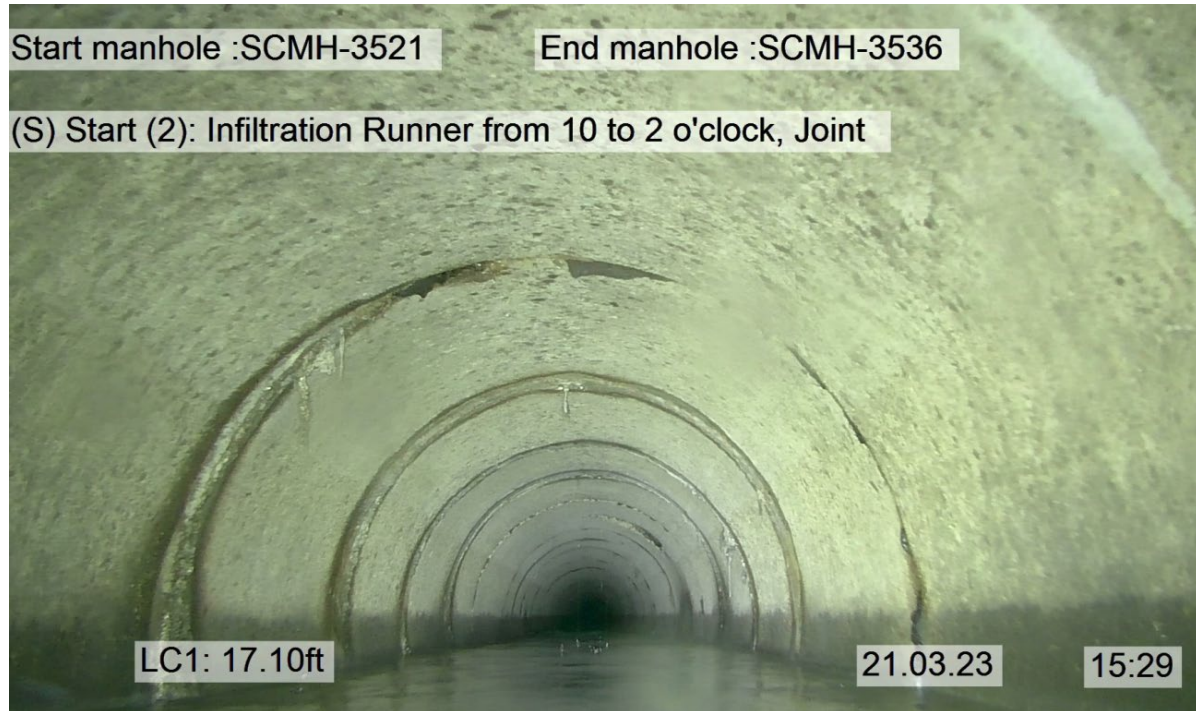
Image at 17.10' shows infiltration.

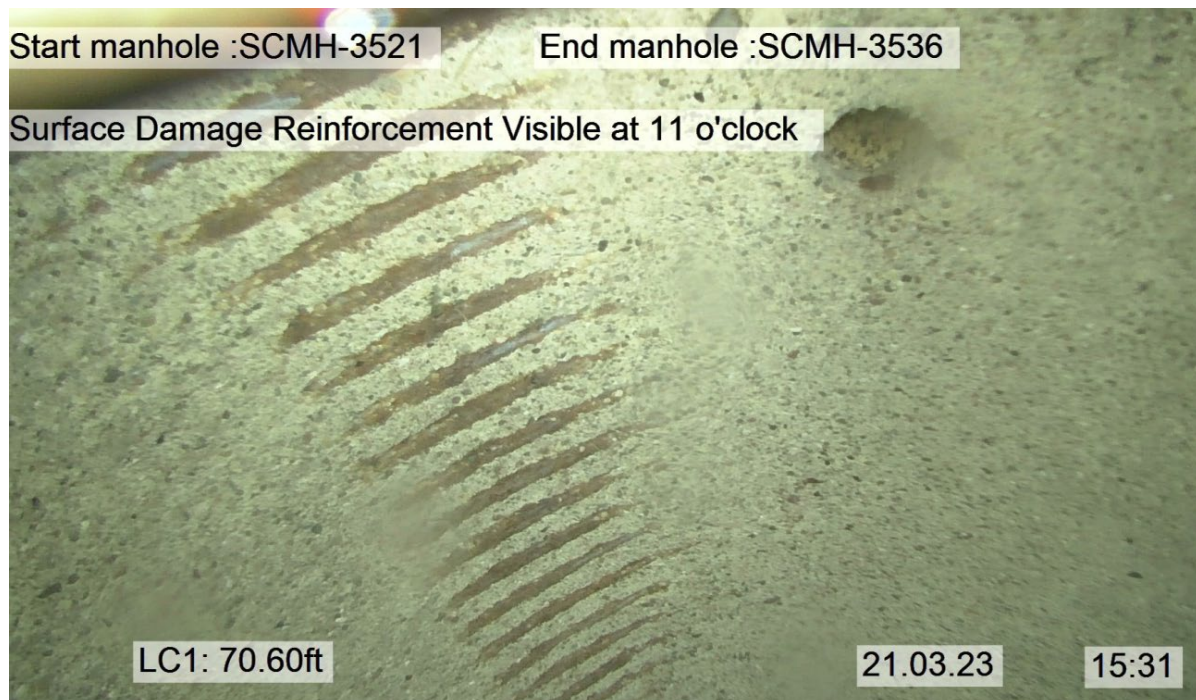
Image at 70.60' shows reinforcement visible.

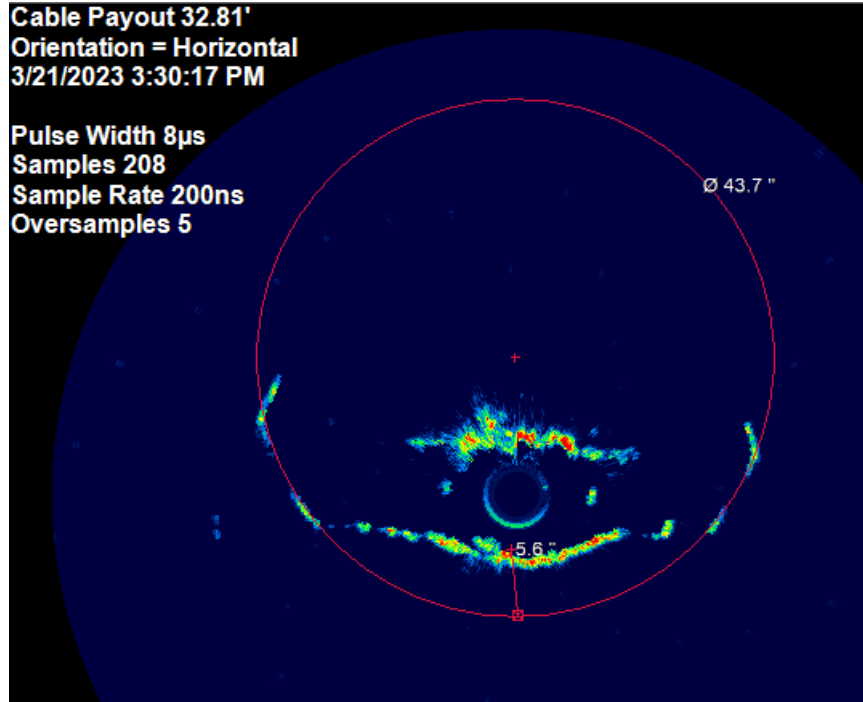
Image at 32.81' shows 5.6" of debris.

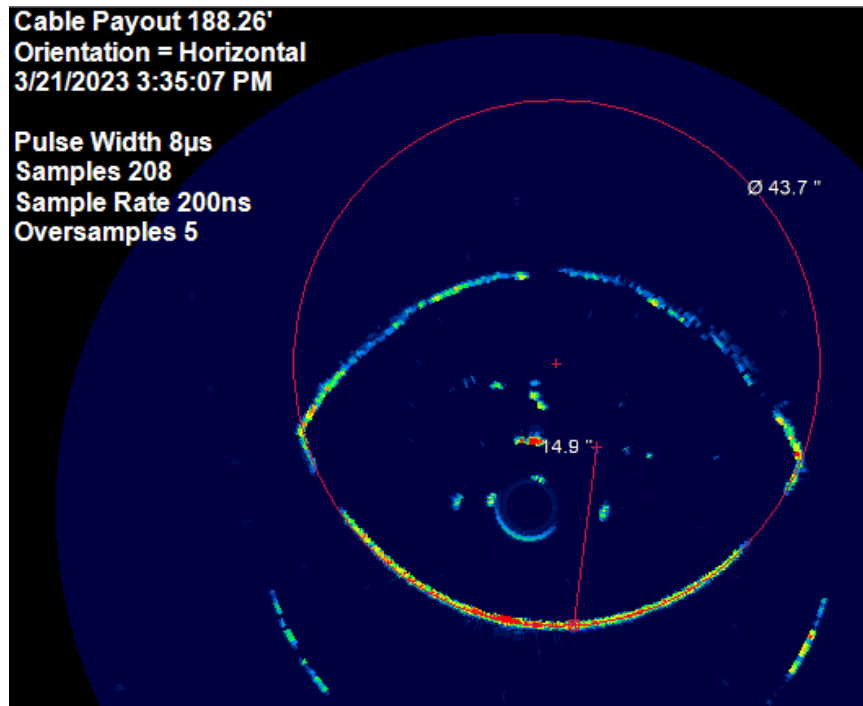
Image at 188.26' shows 14.9" of water.

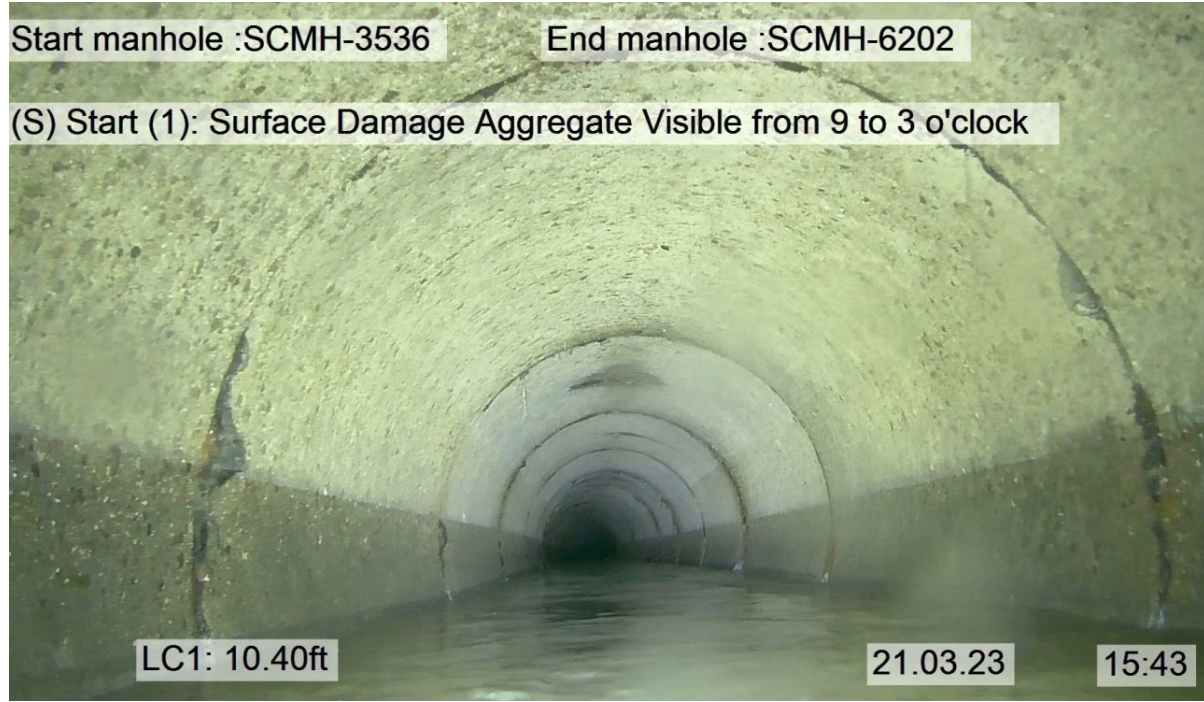
Image at 10.40' shows aggregate visible.

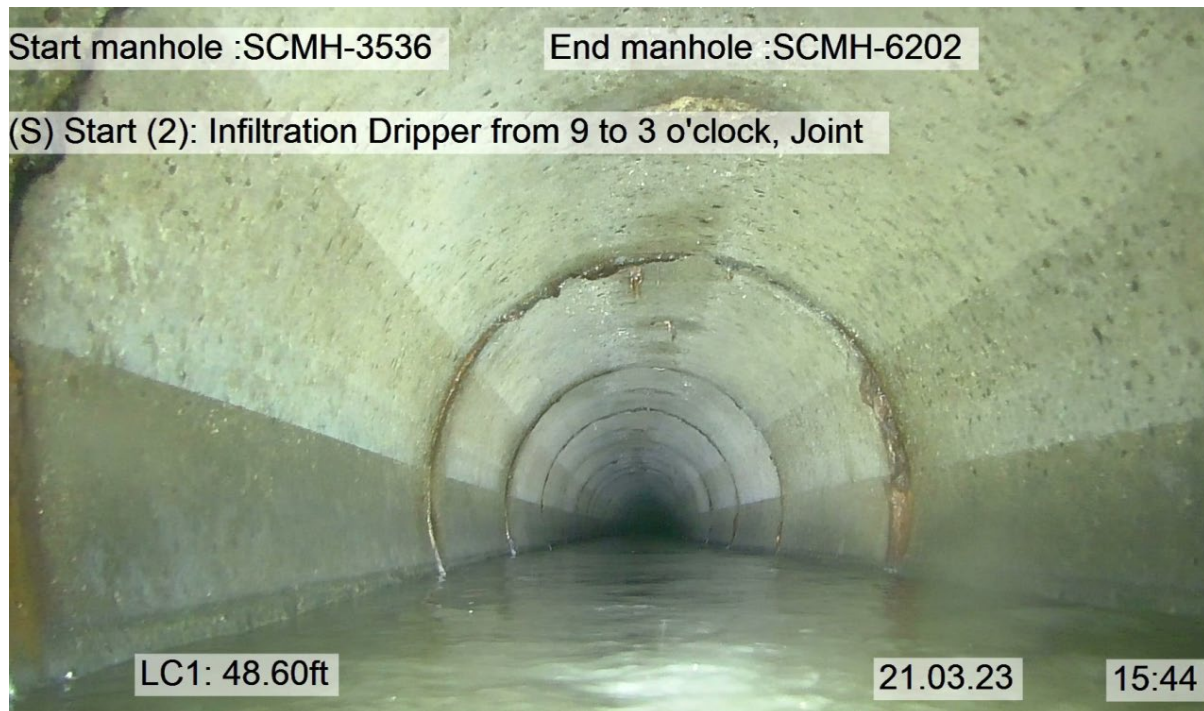
Image at 48.60' shows infiltration.

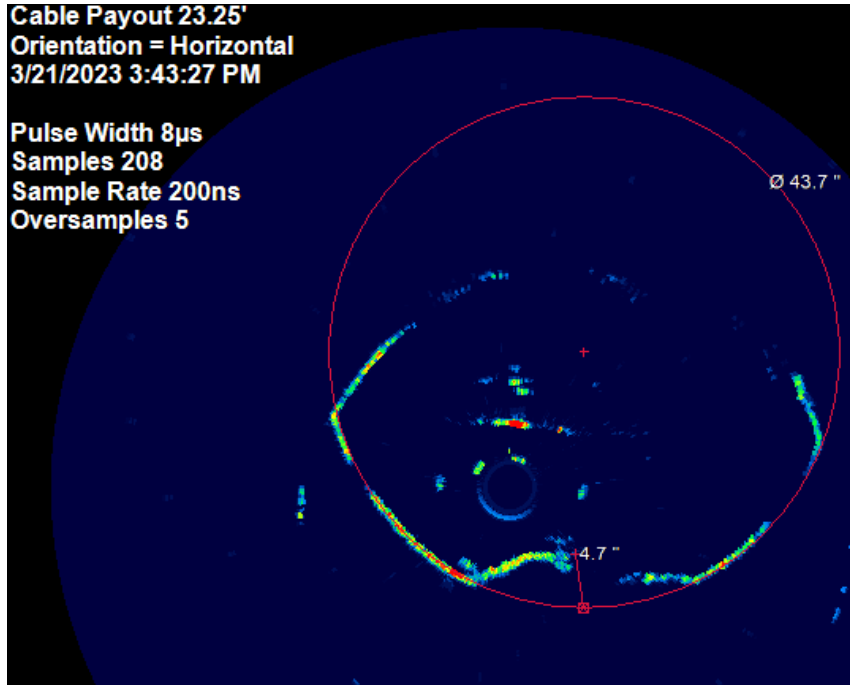
Image at 23.25' shows 4.7" of debris.

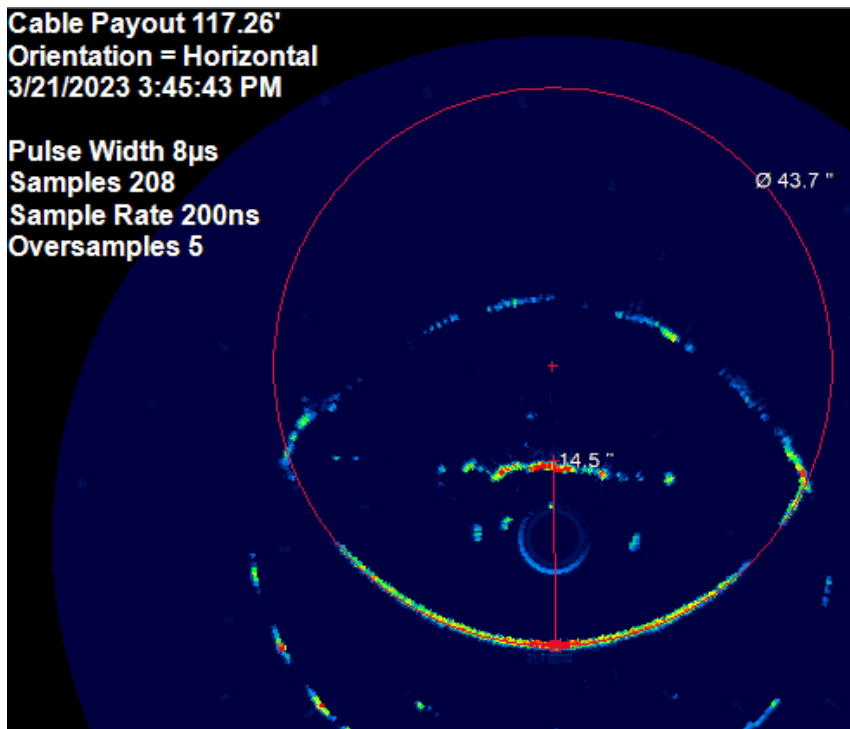
Image at 117.26' shows 14.5" of debris.

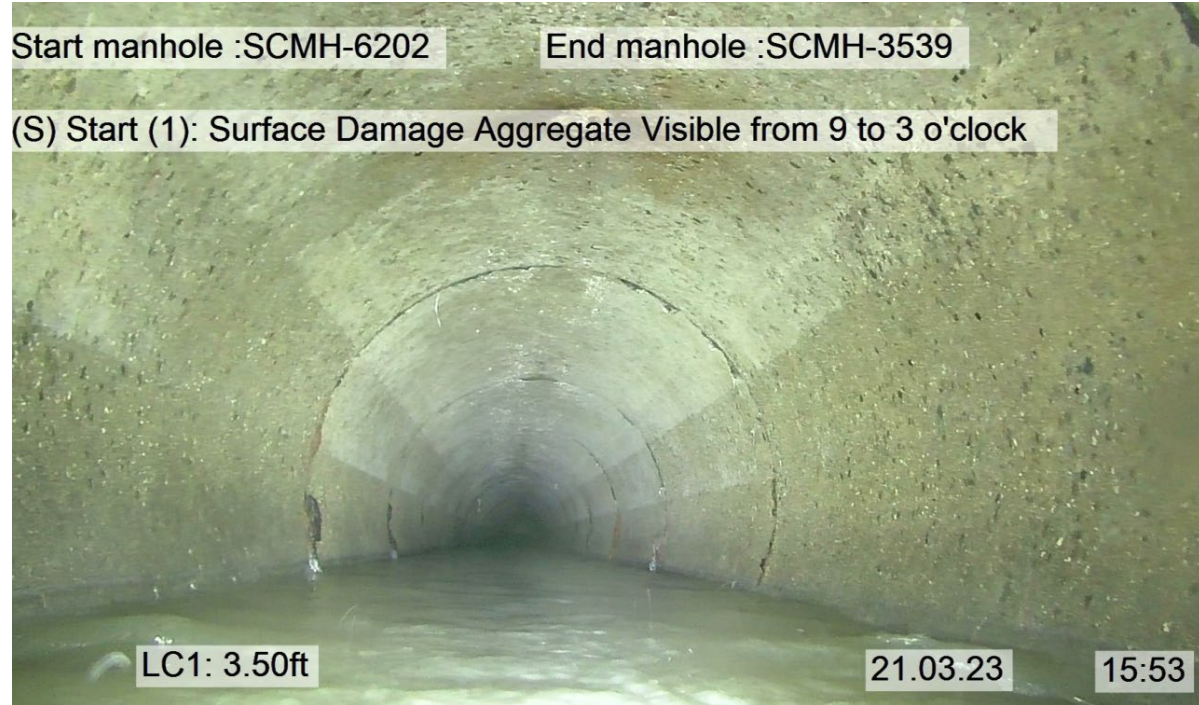
Image at 3.50' shows aggregate visible.

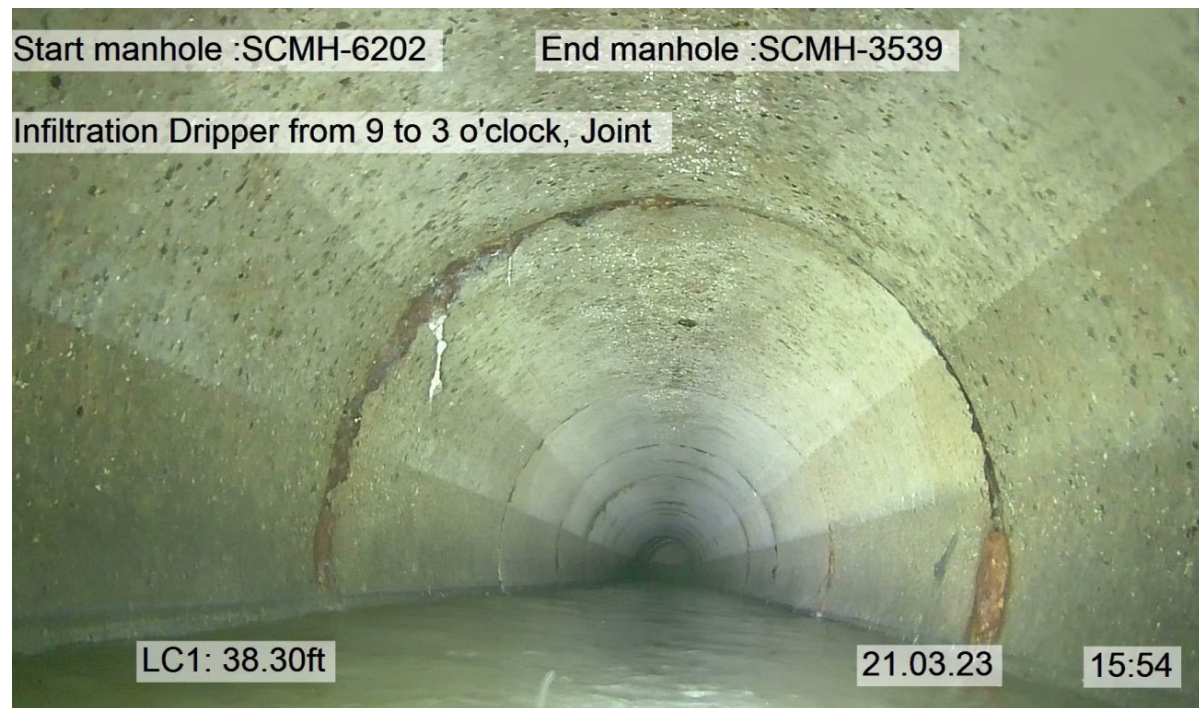
Image at 38.30' shows infiltration.

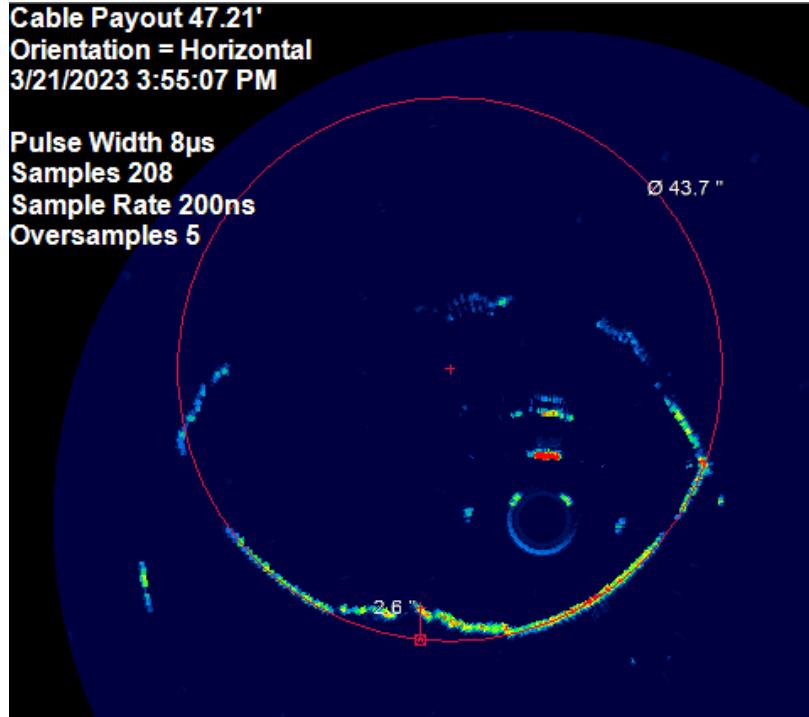
Image at 47.21' shows 2.6" of debris.

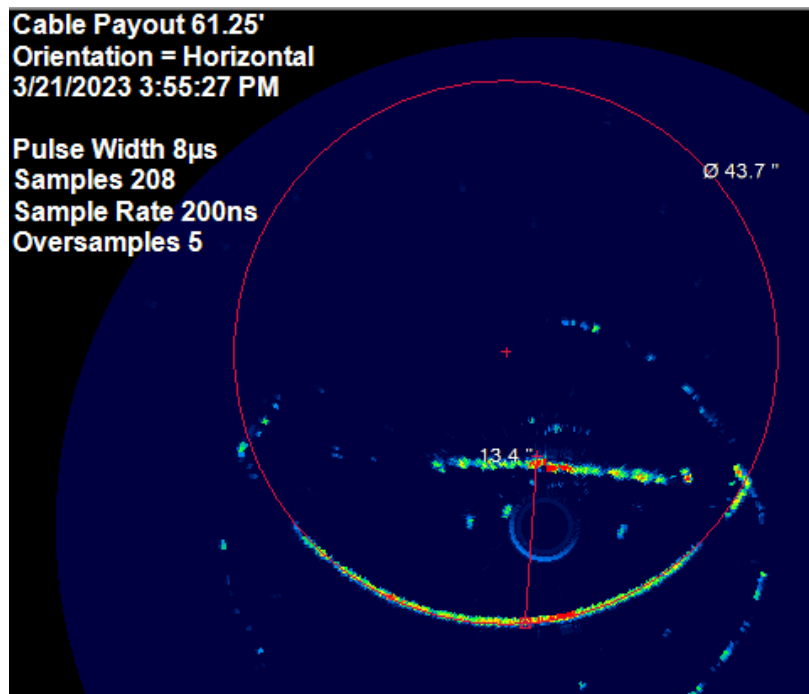
Image at 61.25' shows 13.4" of water.

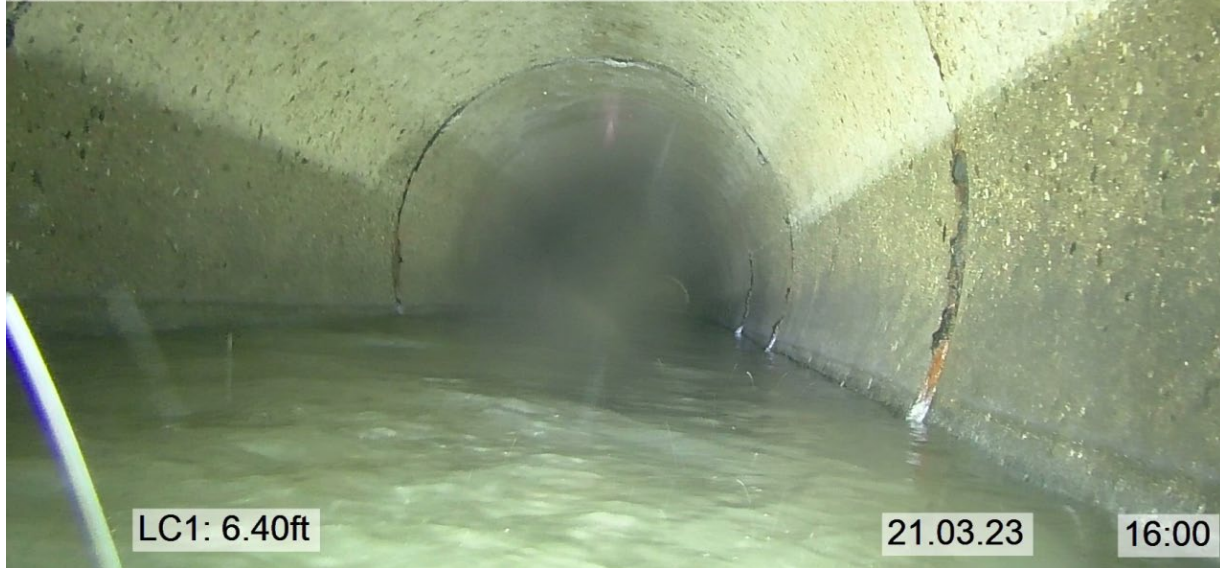
(S) Start (1): Surface Damage Aggregate Visible from 8 to 4 o'clock

Image at 6.40' shows aggregate visible.

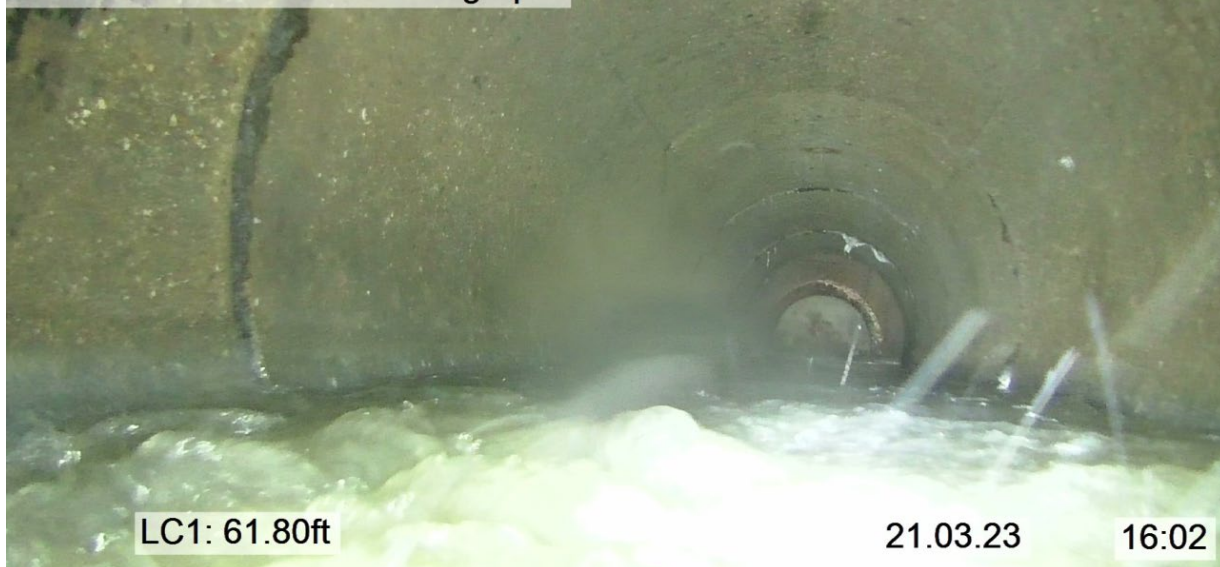
Image at 61.80' shows a general photo of the pipe.

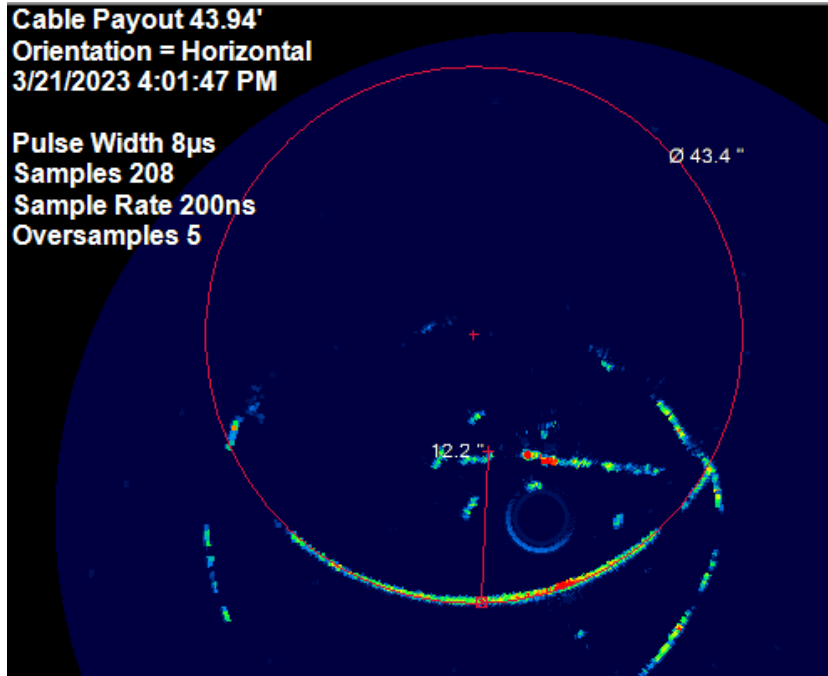
Image at 43.94' shows 12.2" of water.

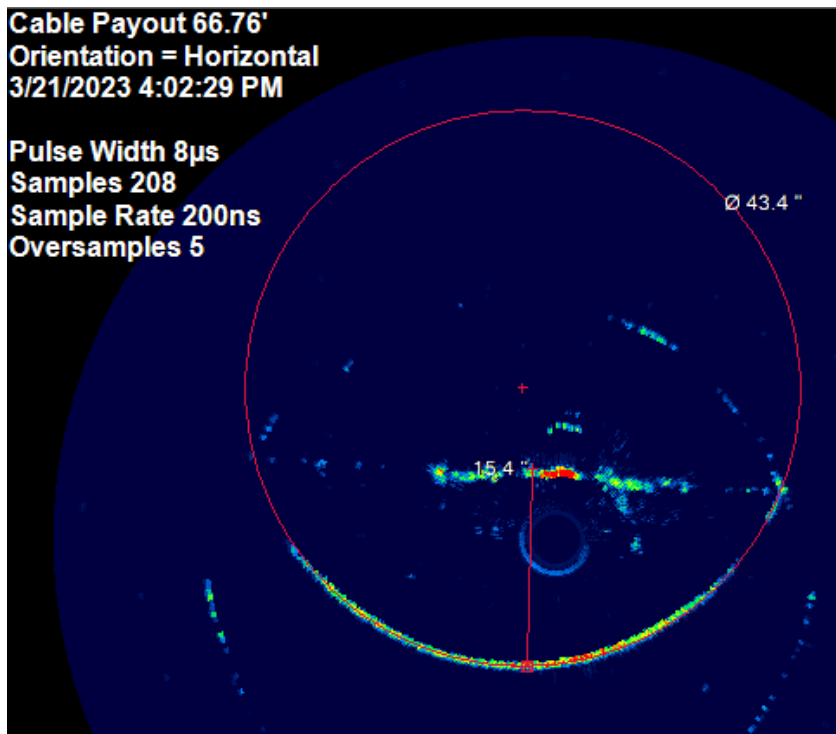
Image at 66.76' shows 15.4" of water.

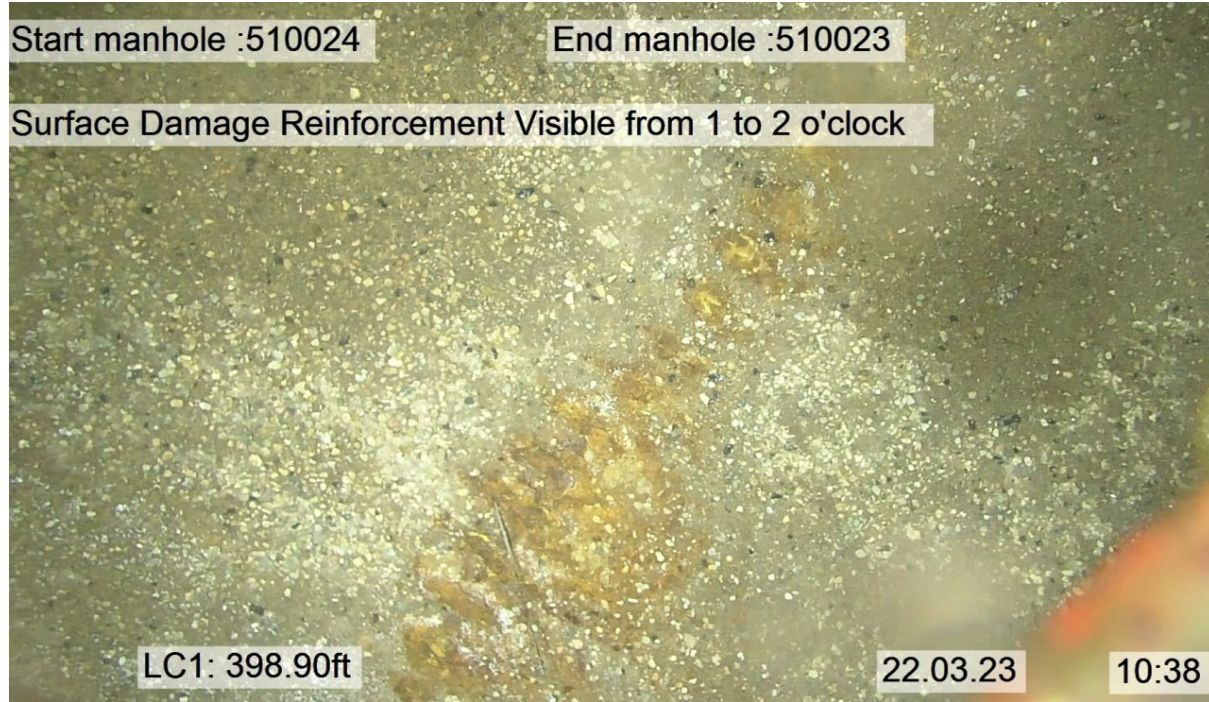
Image at 398.90' shows reinforcement visible.

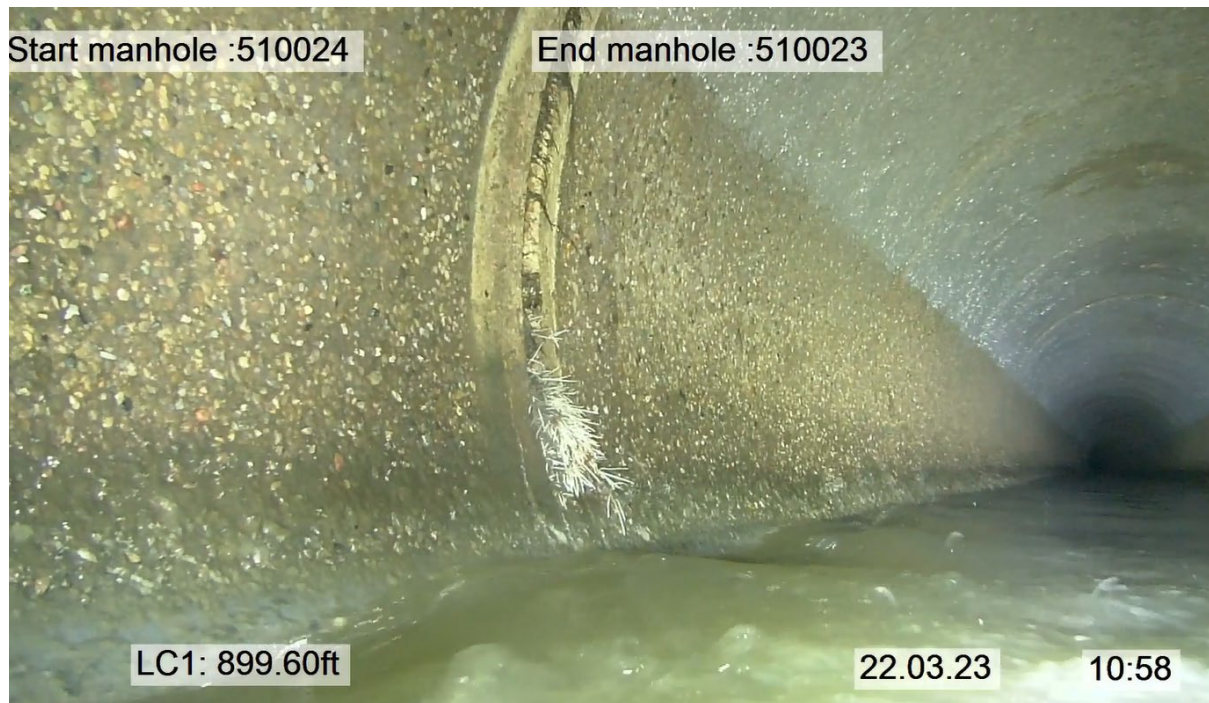
Image at 899.60' shows fine roots.

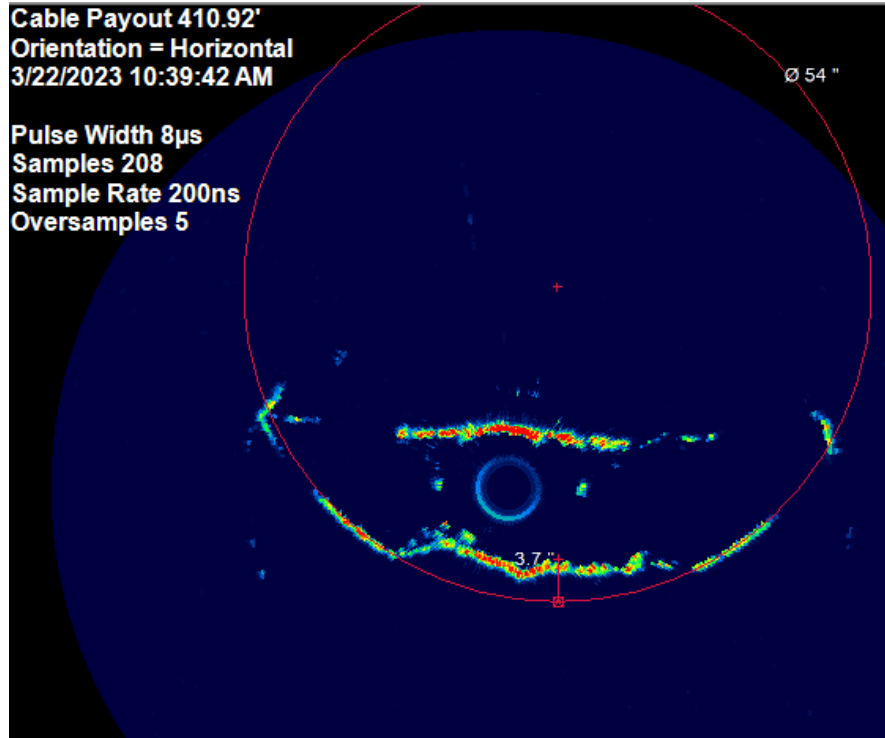
Image at 410.92' shows 3.7" of debris.

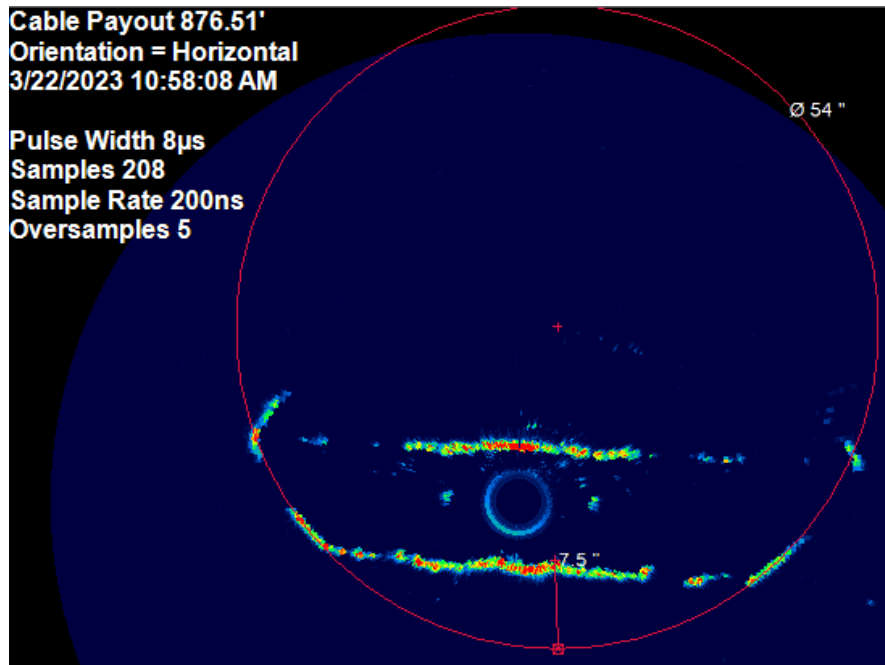
Image at 876.51' shows 7.5" of debris.
