DATA REPORT FOR SONAR/CCTV PIPELINE INSPECTION

Interceptor Inspection

Data Report: **Interceptor Inspection**

Location: The interceptor inspection took place at University Athletic Field parking lot into the woods.

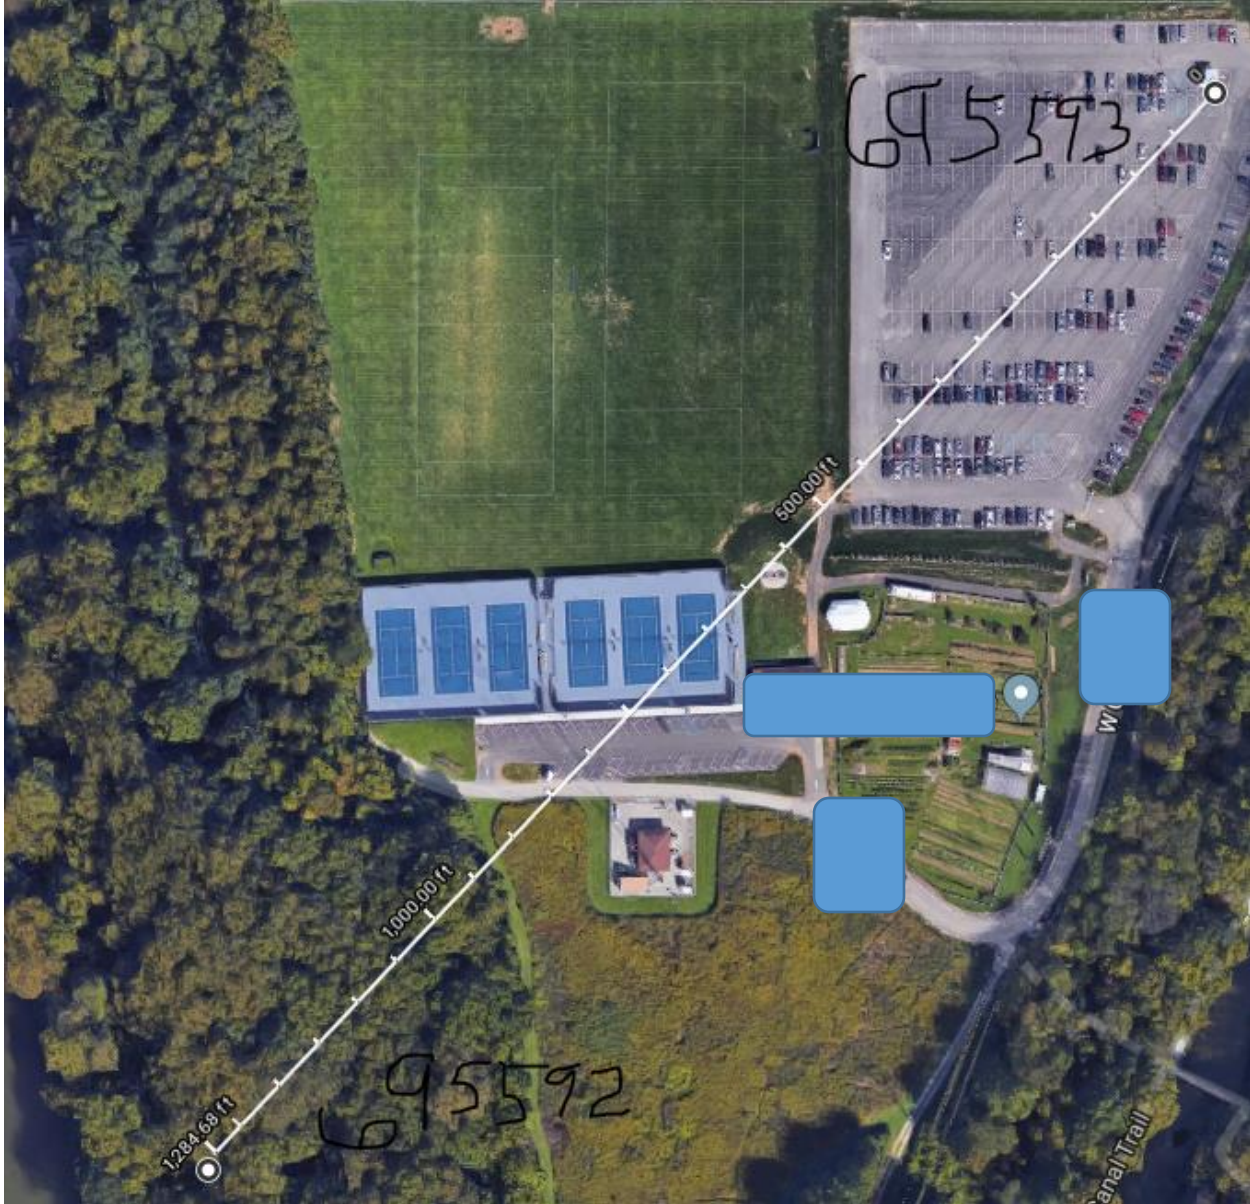
During the inspection of this section of pipe, the field crew was able to get the pipe strung with a rope from manhole to manhole. At around the 800 foot mark they started to notice some roots starting to enter the pipe though the joints. The size of the roots continued to get larger the farther down the pipe that they got. At around 940 feet the roots got be enough that they could not pull the raft down the pipe any longer. The survey had to be abandoned at that point.
