DATA REPORT FOR SONAR/CCTV PIPELINE INSPECTION

1 River Rd Inspection

Data Report: 1 River Rd Inspection

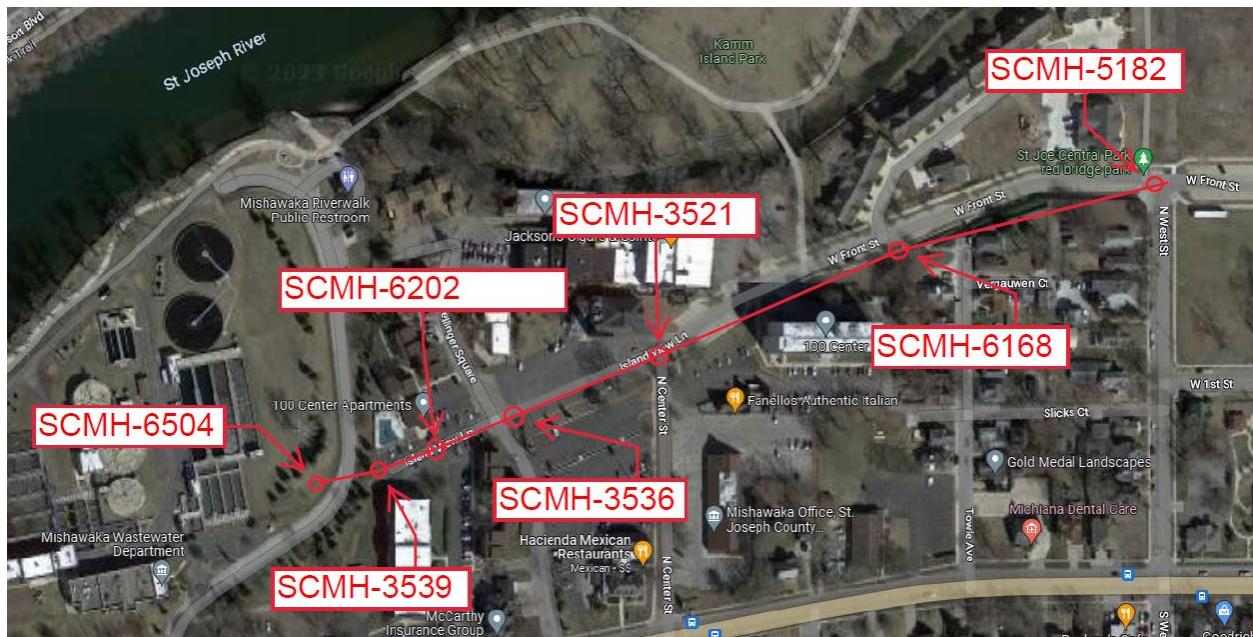
Summary of Condition

Location	Upstream MH	Downstream MH	Pipe Size	Pipe Length	Pipe Material	Problem	Average Debris Amount	Debris Volume
Front St	SCMH-5182	SCMH-6168	42"	348.50'	RCP	Aggregate Visible	1.40"	53.06 Cu Ft
Front St	SCMH-6168	SCMH-3521	42"	595.80'	RCP	Infiltration	.56"	44.00 Cu Ft
Front St	SCMH-3521	SCMH-3536	42"	262.60'	RCP	Aggregate Visible	1.48"	53.70 Cu Ft
Front St	SCMH-3536	SCMH-6202	42"	205.60'	RCP	Aggregate Visible	.18"	3.11 Cu Ft
Front St	SCMH-6202	SCMH-3539	42"	102.90'	RCP	Aggregate Visible	1.09"	15.26 Cu Ft
Front St	SCMH-3539	SCMH-6504	42"	85.50'	RCP	Aggregate Visible	0.00"	0.00 Cu Ft

R&R started these inspections at SCMH-5182 headed downstream. Continuing down into the Shop Wastewater Department fenced in area. There were a few spots in these lines that had some debris in them. There were also spots that had some aggregate visible and infiltration. When trying to send a piece of equipment through SCMH-5182 to SCMH-6168 it did get hung up on something for a little while. It could have been some debris underwater, but when it came out it had a very large ball of rags attached to it.

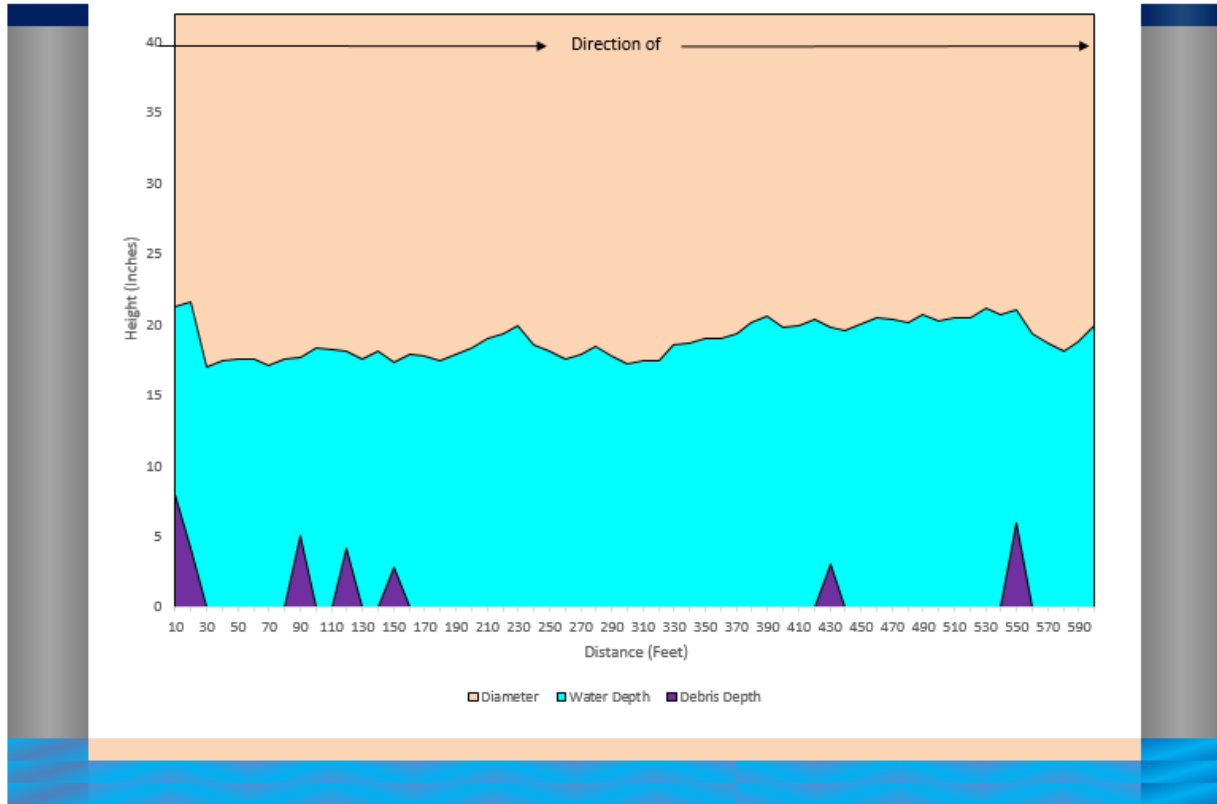
Pipeline Debris Graph

Diameter: 42 Inches
Avg. Debris Depth: 0.56 Inches
Avg. Water Level: 18.97 Inches
Approx. Debris Vol.: 44.00 Cubic Ft.

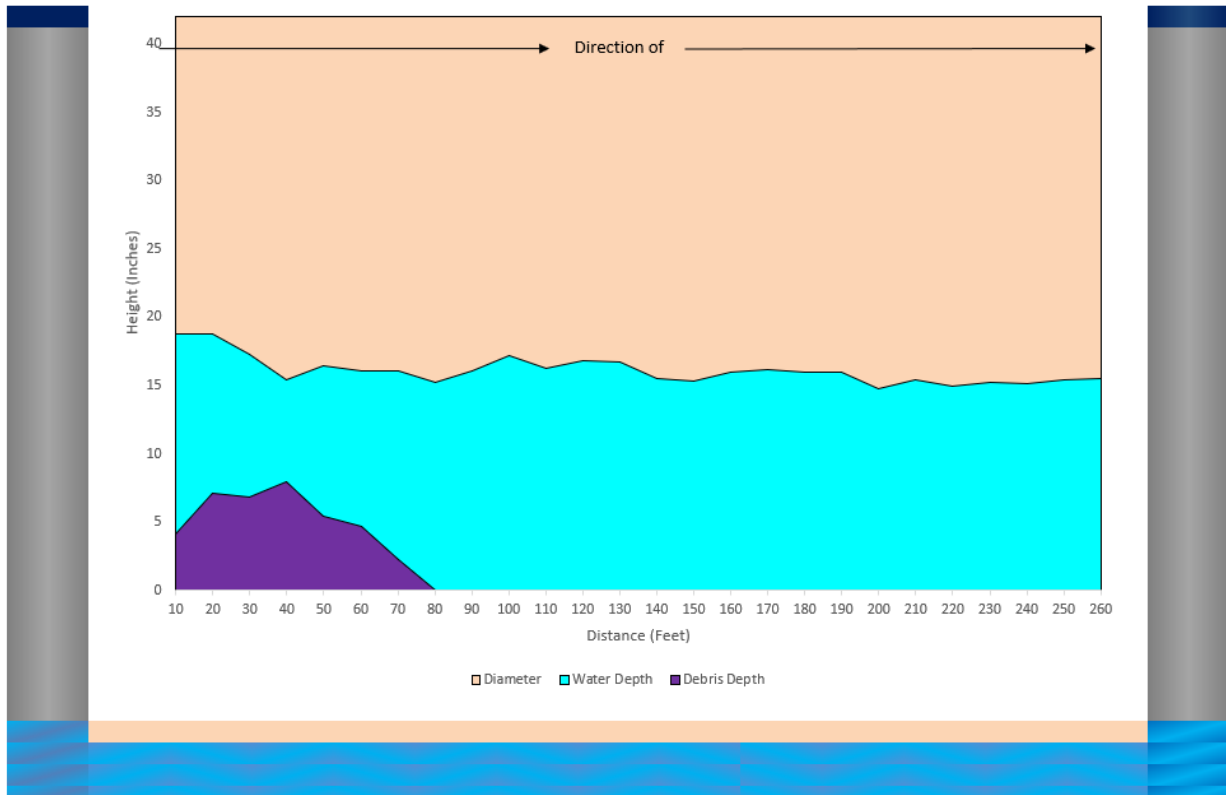
Pipeline Debris Graph

Diameter: 42 Inches
Avg. Debris Depth: 1.48 Inches
Avg. Water Level: 16.10 Inches
Approx. Debris Vol.: 53.70 Cubic Ft.

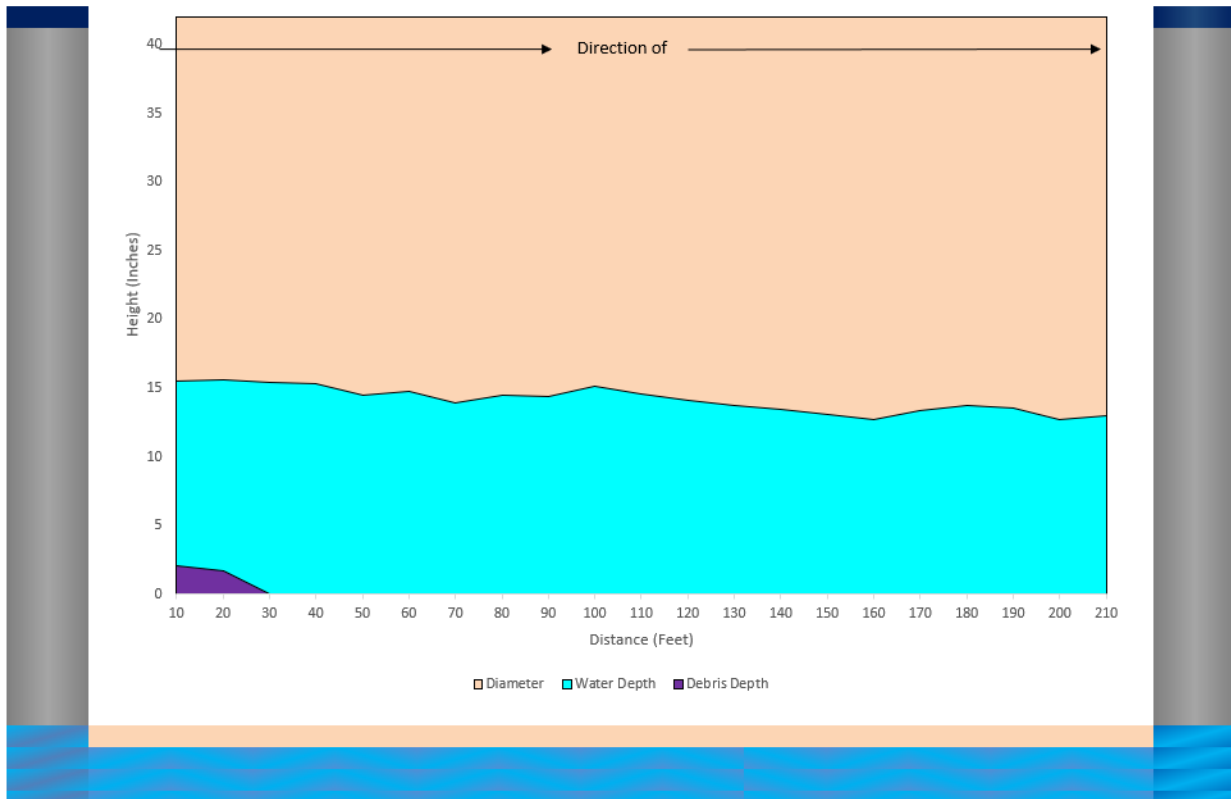
Pipeline Debris Graph

Diameter: 42 Inches
Avg. Debris Depth: 0.18 Inches
Avg. Water Level: 14.15 Inches
Approx. Debris Vol.: 3.11 Cubic Ft.
